TITLE: 3" TO 2" RIGHT HAND LOADING ARM ASSEMBLY
 DATE: 7/2/2018
 MATERIAL: SEE B.O.M.

PART NUMBER: **LA-SH0518206** Rev. A

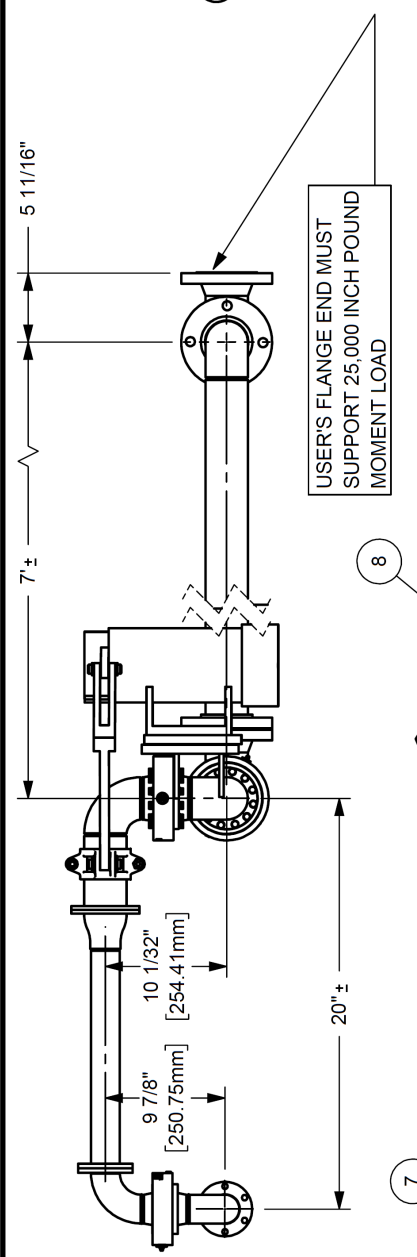
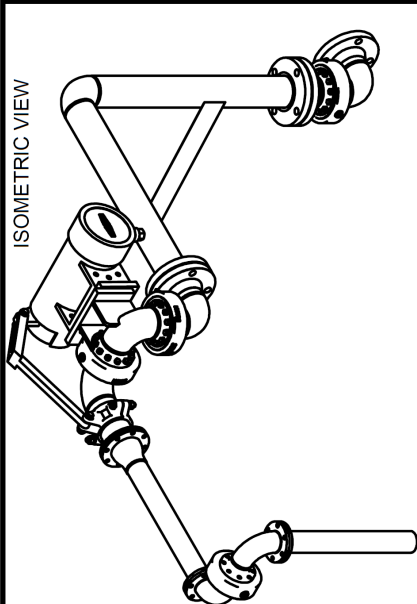
ITEM NO.	PART NUMBER	DESCRIPTION	MATERIAL	QTY.
9	ESB1-3-CLAMP	COUNTERBALANCE CLAMP	IRON	1
8	ESB1-A	COUNTERBALANCE	MISC.	1
7	SF240TFXFSS	2" STYLE 40 SPLITFLANGE WITH TTMA FLANGES WITH LONG RADIUS ELBOWS	STAINLESS STEEL	1
6	LEG D: 2LSS-TFXM-81	2" SCHEDULE 40 PIPE WITH TTMA X MALE NPT	STAINLESS STEEL	1
5	LEG C: 2LSS-TFXTF-4 CR	2" SCHEDULE 40 PIPE WITH TTMA AND CONCENTRIC REDUCER	STAINLESS STEEL	1
4	SF370FGXFSS	3" STYLE 70 SPLITFLANGE WITH TTMA, CB MOUNT AND CONCENTRIC REDUCER	STAINLESS STEEL	1
3	BRACE	1/2" STEEL BRACE	STAINLESS STEEL	1
2	LEG A: 3LSS-FGXFG-72" & 72" WITH ELBOW	3" SCHEDULE 40 PIPE WITH 150 lbs. SLIP-ON FLANGES AND ELBOW	STAINLESS STEEL	1
1	SF330FGXFGSS	3" STYLE 30 SPLITFLANGE WITH 150 lbs. FLANGES	STAINLESS STEEL	1

Loading arms have been designed to work in a set range of motion and calculated to balance the provided equipment. If additional items are installed (such as tie-down chains, drip buckets, valves, vapor hoses etc.) it will adversely affect the balance and range of the loading arm. All loading arms are custom made to order and are not returnable, however Dixon is committed to providing a solution to any unforeseen issue.
